NORWEGIAN SEISMIC ARRAY

NORSAR Report No 32
Budget Bureau No 22-RQ293

Field Maintenance Report

1 January - 30 September 1971

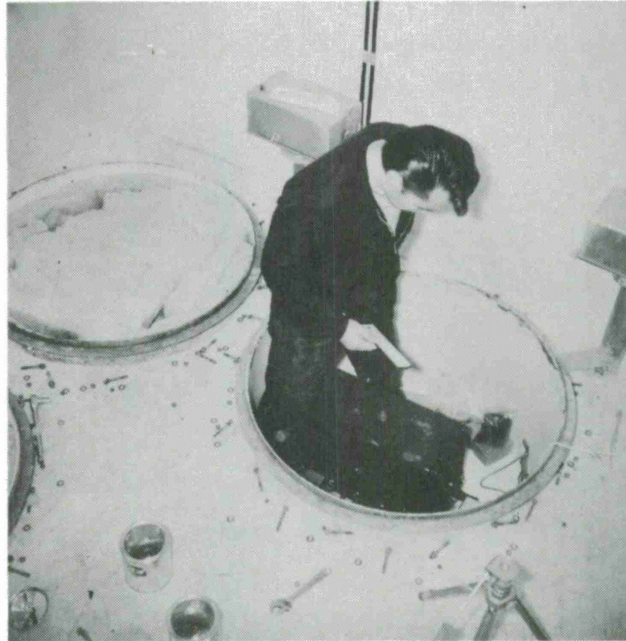
Figure 3.1 The NS and the EW tanks opened,
the NS tank with insulating pads in.

During the following weeks measurements were made at the DPC for noise and performance. The heating was switched on and off, the noise level being monitored and compared with the adjacent seismometer, which was for the occasion mounted parallel to the first. No deterioration of performance caused by the heating could be detected, and repeated inspections in the tanks showed largely reduced humidity in the heated tank.

Figure 3.1 shows the NS and the EW tanks opened, the NS tank filled up with insulating pads around and on top of the seismometer, while the pads are removed from the EW tank. A bag of dehydrating substance can be seen beside the seismometer. The technician is returning the thermometer before the lids are put back on.

Based on information from the previous seismic station at Ringsaker, which utilized installations of somewhat the same kind as at NORSAR, we proposed to introduce an electric heating element in the LP tanks to increase the air temperature somewhat, in an effort to reduce the moisture in the tanks.

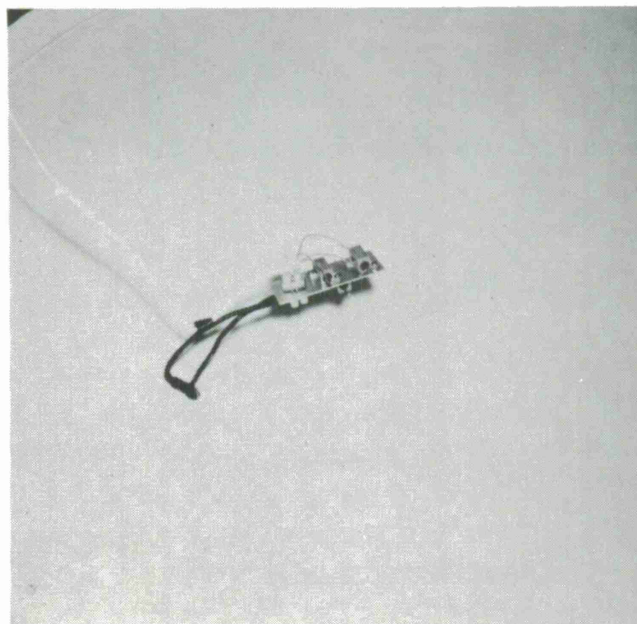
Figure 3.2 The heating element as it was installed
underneath the tank lid.

Figure 3.2 shows the heating element as it was placed underneath the lid.

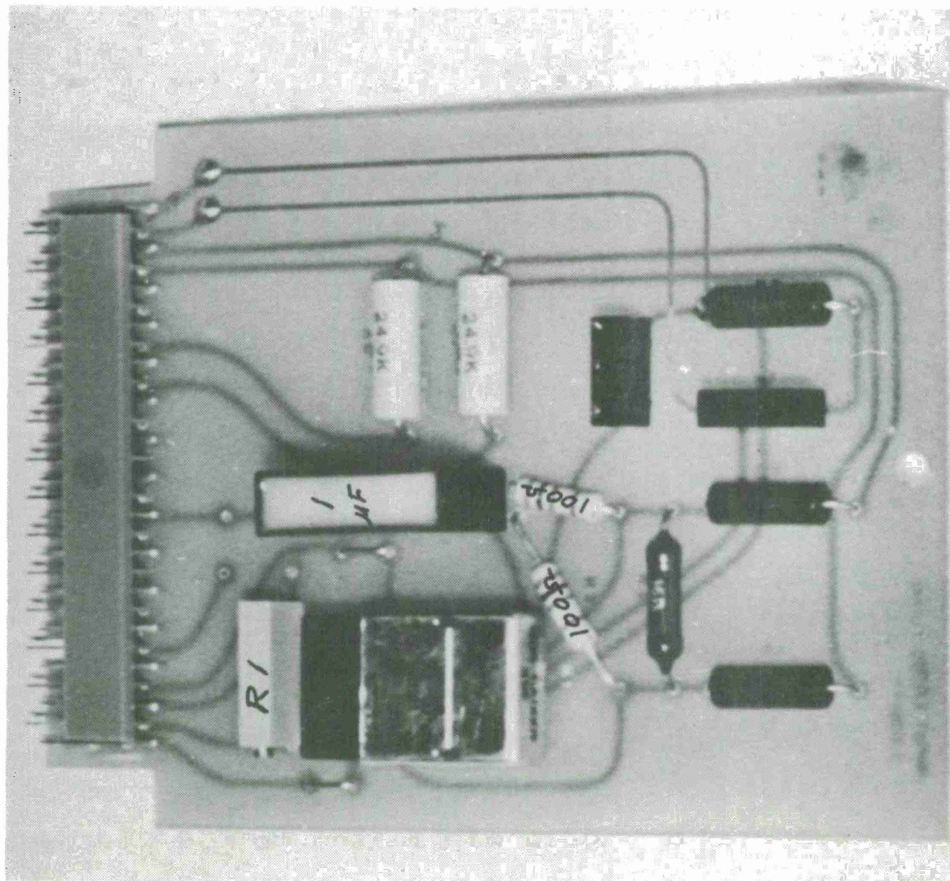
Figure 4.1 Modified RA5 Input Card
Type used at 01C.

Figures 4.1 and 4.2 show modified RA5 Input Cards of respectively "Type used at 01C" and "Type used throughout the array except at 01C". Apart from the damping resistor R1 modification, the cards are also modified as earlier mentioned for suppression of 50 Hz noise in Cal.Amp. mode. The resistor R6 of 200 ohm is replaced by two resistors of 100 ohm in series and grounded over a 1 uF capacitor. Figure 4.3 shows a technician adjusting damping resistor at the WHV, while figure 4.4 shows the test setup in the CTV. By cooperation between WHV and CTV two technicians can now easily adjust the D to proper value.

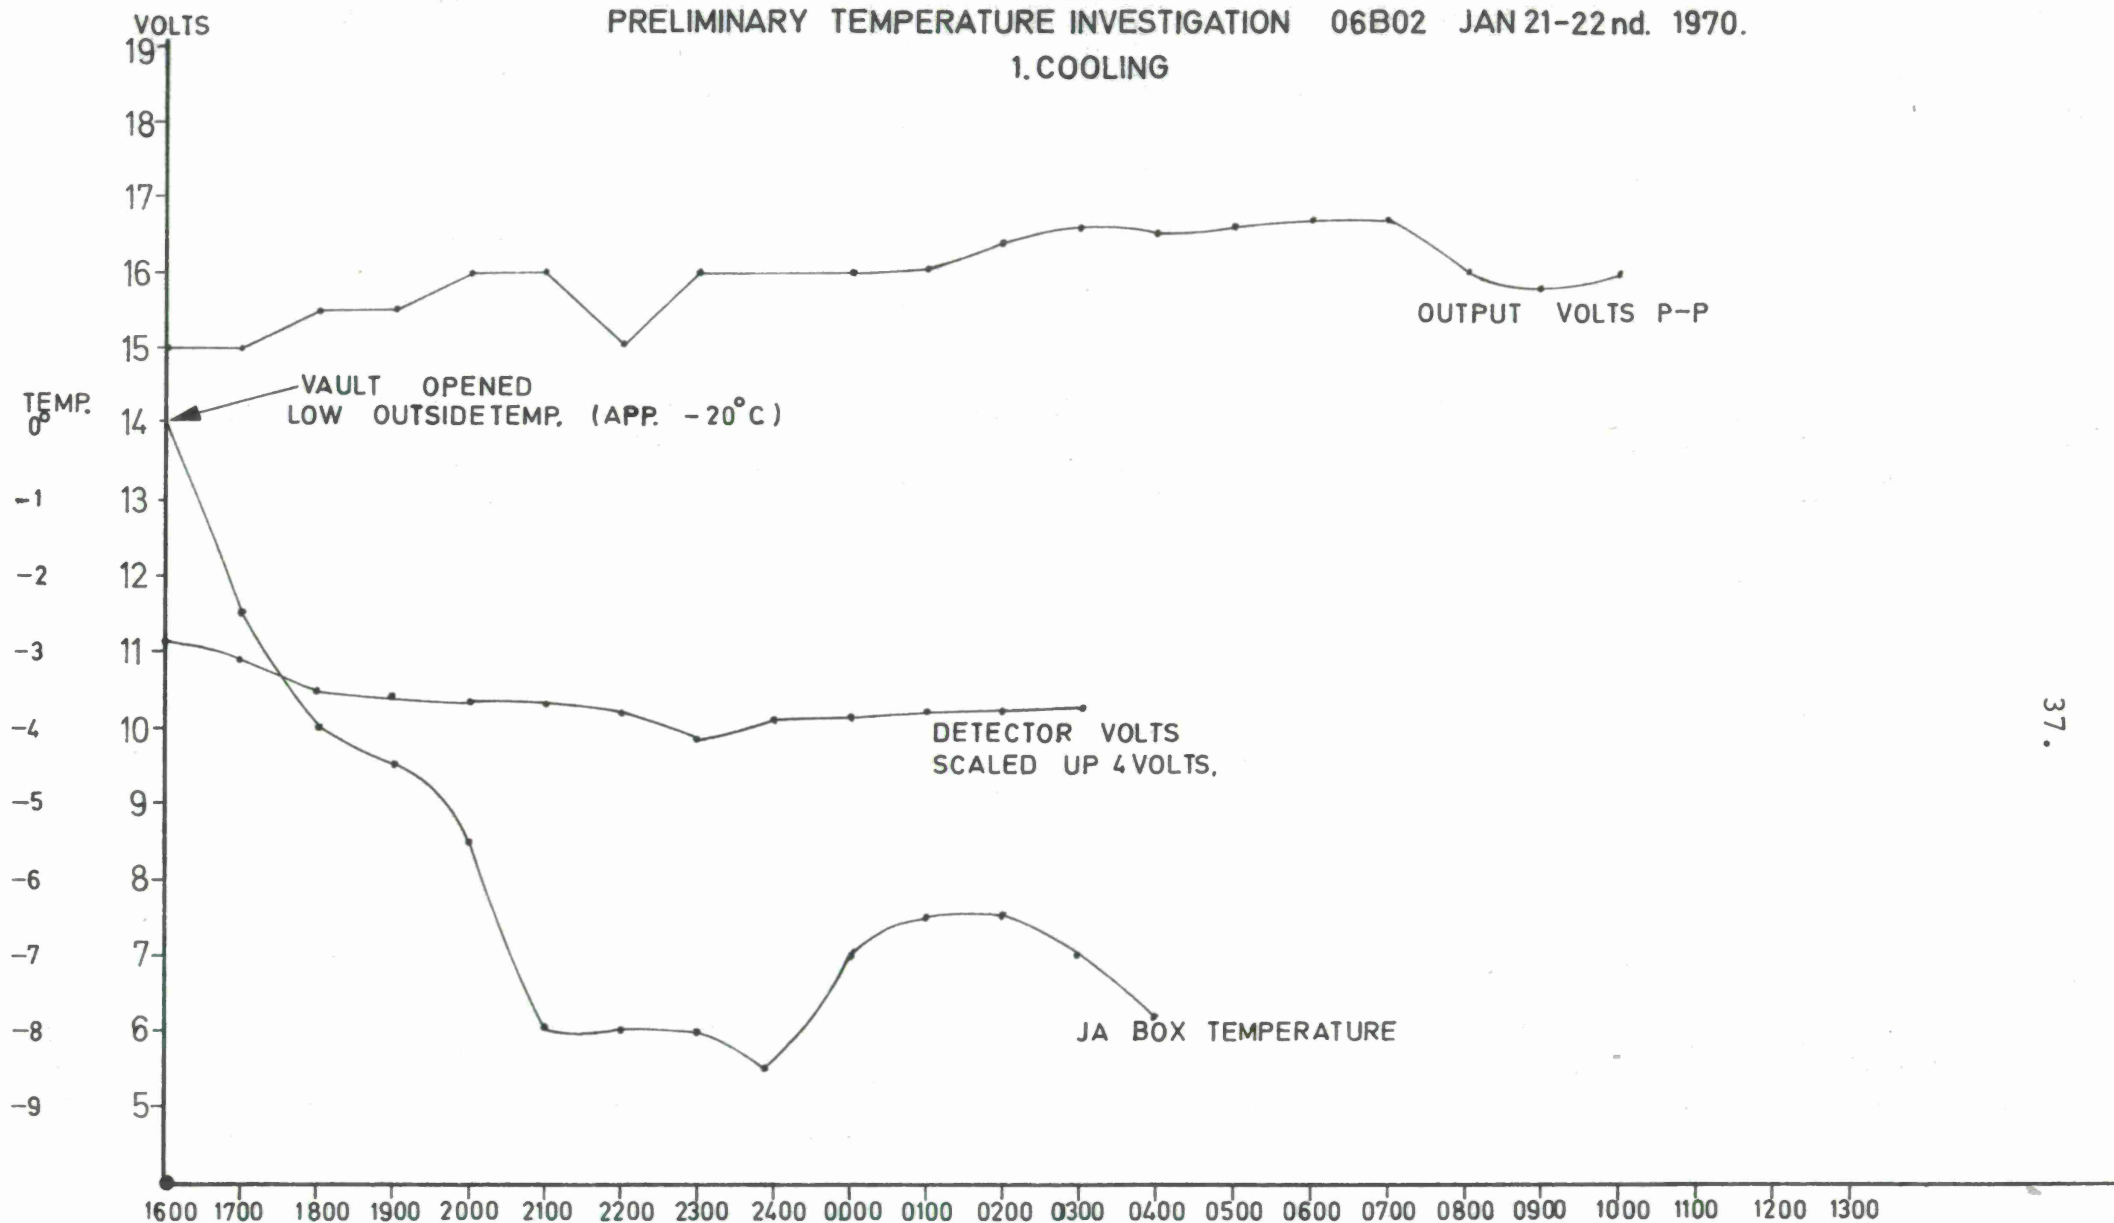
Figure 5.2

The attached curve indicates the decrease in detector voltage with decreasing temperature from 7.1 Volt at 0 degrees to 5.2 Volts at -8°C. (Table 5.2, Fig 5.2, 5.3).

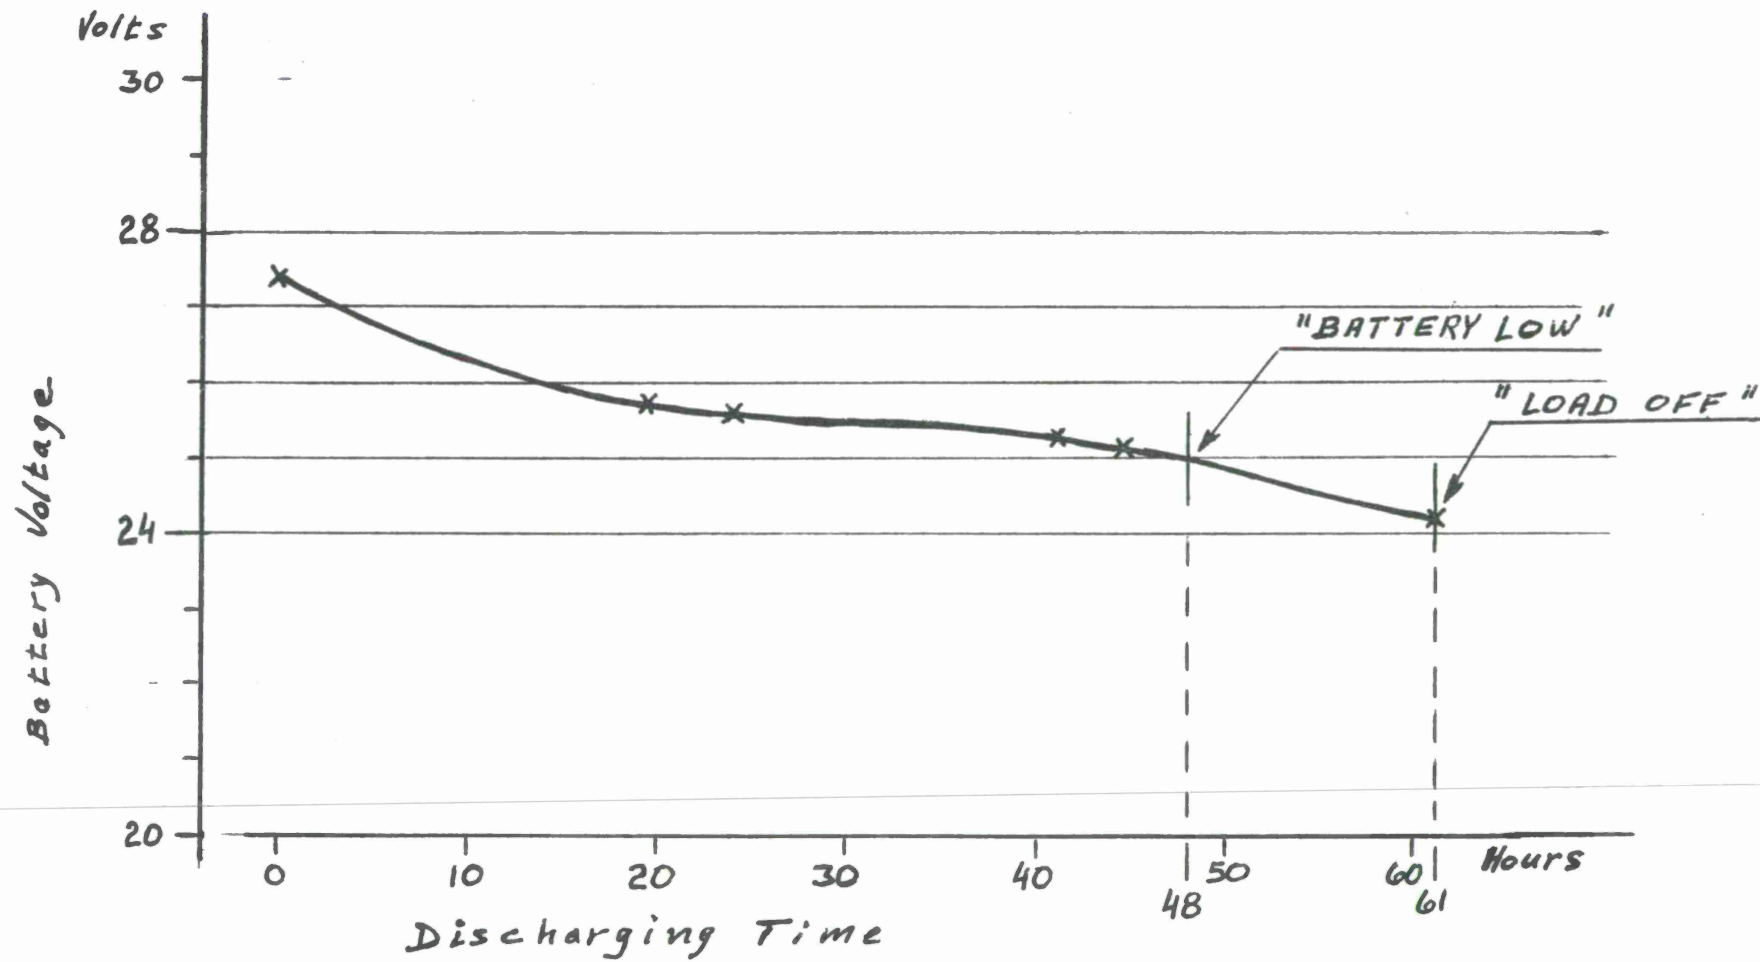
Figure 6.1 Discharging of Fully Charged Battery.

The main power was disconnected, and the normal load was carried by the battery. The result is shown in figure 6.1.

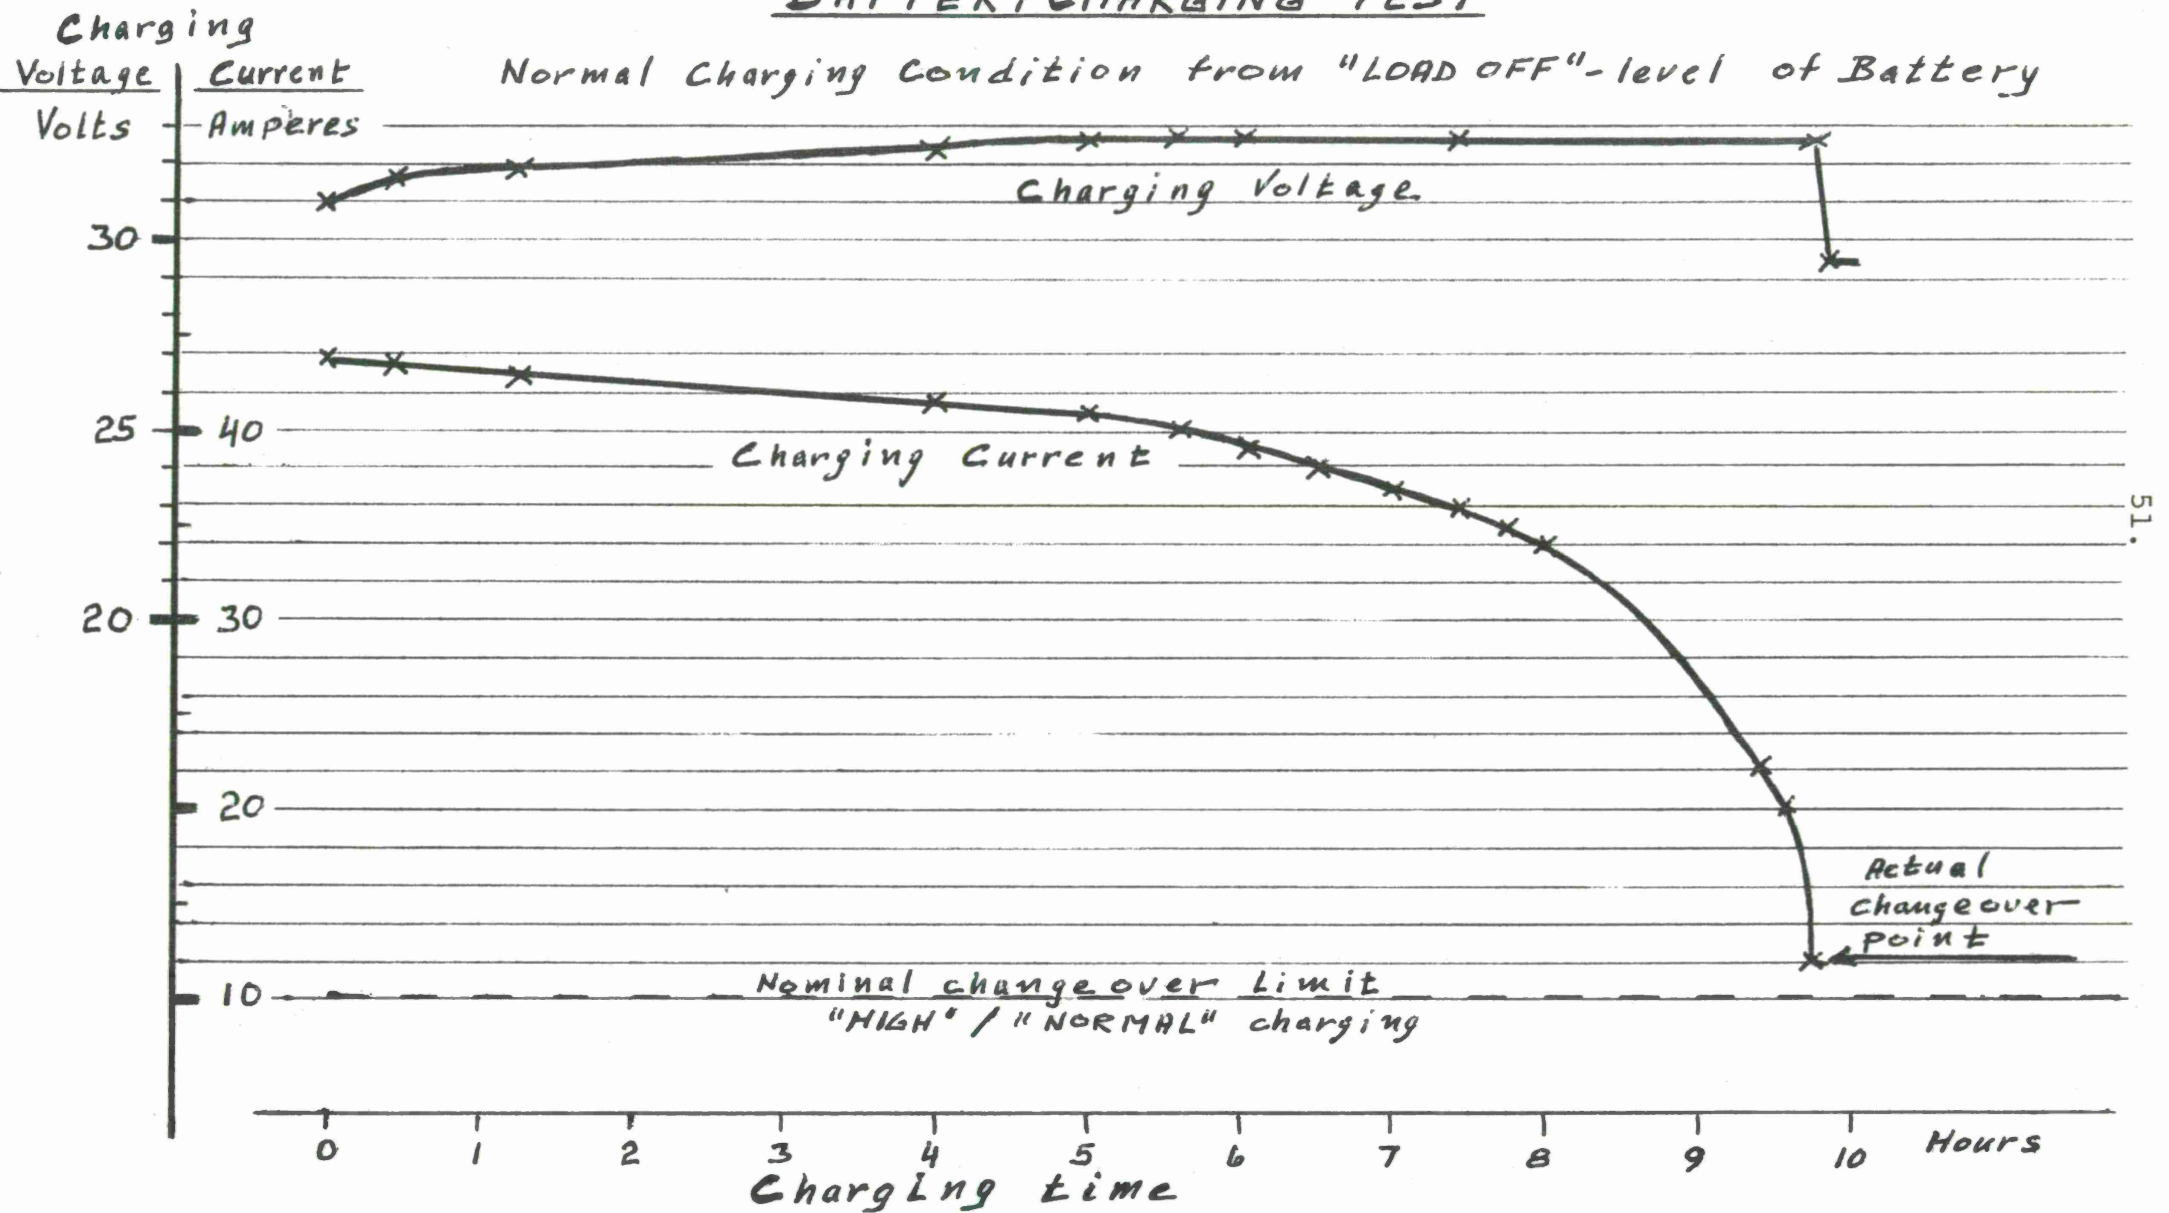
Figure 6.2 Normal Charging Condition from "LOAD OFF"-level of Battery.

The main power was reconnected and normal charging-progress went on. The result is shown in figure 6.2.

The charging rate started with 40A, dropping quickly to 12-14A and had come down to 8.75A after 5 hours.

Because the charging current quickly drops to nearly the same level as with "NORMAL" or maintenance charging and the gassing does not seem to be too inconvenient, it should not be necessary to set the Time Delay Relays lower than 9 - 10 hours, which is necessary for quick recharging of the batteries after mains dropout. See figure 6.2.
